Manhole Inspection Summary

Manhole # S67G__017MH

Insp Date: **5/27/08 7:39 AM**

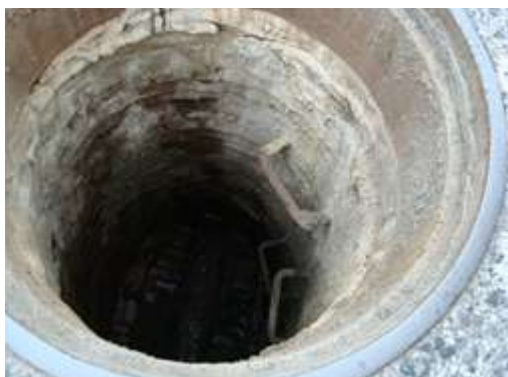
Defect 2

infiltration

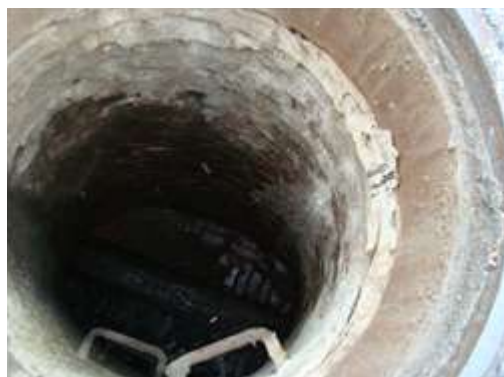
Defect 1

infiltration

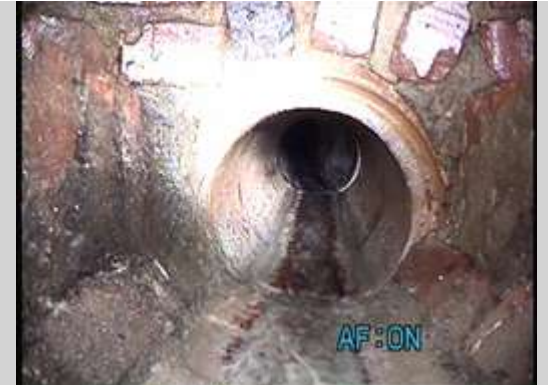
12 O'Clock Outflow

8 in. Circular Gravity Sewer
Pipe Out @ 12 O'Clock

Pipe Height: **8.4** (in.) Rod and Bar (Angled)
Pipe Material: **Clay** ☐ Pipe Lined
Invert Depth: **10.20** (ft.) Flow Characteristics: **Fast**
Deposits: ☒ None ☐ Mud ☐ Sludge ☐ Debris ☐ Grease
Silt Depth: (in.) Deposits Extent:
Infiltration: **None** Pipe Seal Cond: **Sound**

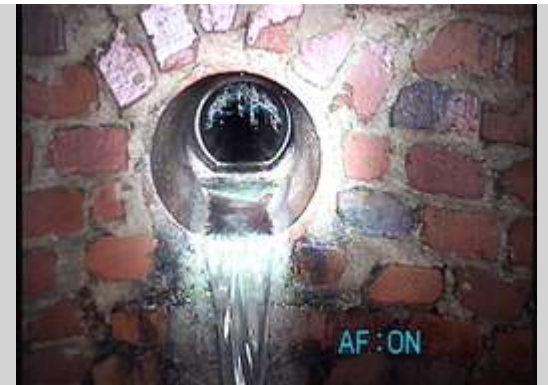
6 O'Clock Inflow

8 in. Circular Gravity Sewer
Pipe In @ 6 O'Clock

Pipe Height: **8.4** (in.) Rod and Bar (Angled)
Pipe Material: **Clay** ☐ Pipe Lined
Invert Depth: **8.55** (ft.) Flow Characteristics: **Fast**
Deposits: ☒ None ☐ Mud ☐ Sludge ☐ Debris ☐ Grease
Silt Depth: (in.) Deposits Extent:
Infiltration: **None** Pipe Seal Cond: **Sound**

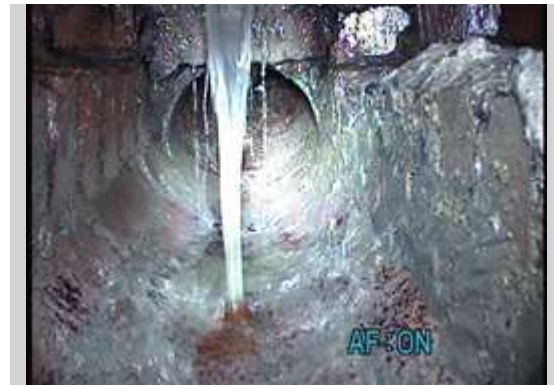
Drop In @ 6 O'Clock

Drop: **Inside** Rod and Bar
Angled: **Yes** Reading: **8.85** (ft.)
Inv Depth: **9.85** (ft.)

Drop Condition: **Open**
